MISCELLANEOUS PAPER SL-81-14

# EVALUATION OF CONDITION OF LAKE SUPERIOR REGULATORY STRUCTURE SAULT STE. MARIE, MICHIGAN

June 1981  
Final Report

Prepared for U. S. Army Engineer District, Detroit  
Detroit, Michigan 48231

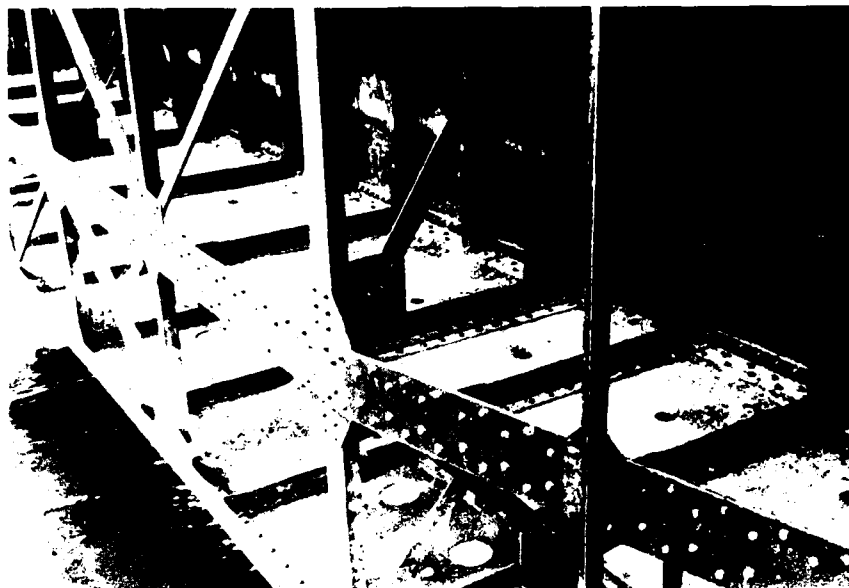
Figure 8. View of downstream side of sluice gate

21. Ultrasonic inspection (rivets) results. The rivets used to fabricate the sluice gates were of medium steel, 7/8-in. diam, and had round heads (see Figure 8). The round heads made it extremely difficult to check the rivets for continuity using ultrasonic inspection. After consulting with experts in the conduct of these types of tests,

it was determined that there were no alternatives to ultrasonics that would simplify or substitute for this type of measurement. It was apparent from the outset that satisfactory contact between the ultrasonic transducer and the rivet could not be made without grinding the head of the rivet. This had to be done by hand and was very tedious since the surface had to be flat and normal to the rivet axis. The degree of difficulty, the time and access restrictions imposed by a stringent schedule of gate manipulation, and the fact that field personnel were needed to complete other work resulted in a limited effort in rivet inspection. Plates B9 and B10 show the locations and results of measurements made on gates No. 11 and 12. A total of 60 rivets were sounded. Only six measurements indicated possible flaws. These flaws, if they were present, were very near the end of the rivet in each case. The fact that these six indications of defective rivets could have been caused by a lack of normalcy between the plane of contact and the rivet axis allows one to speculate that maybe none of the rivets tested were defective. The results of these tests do not show cause for concern about the rivets with respect to the integrity of the gates.

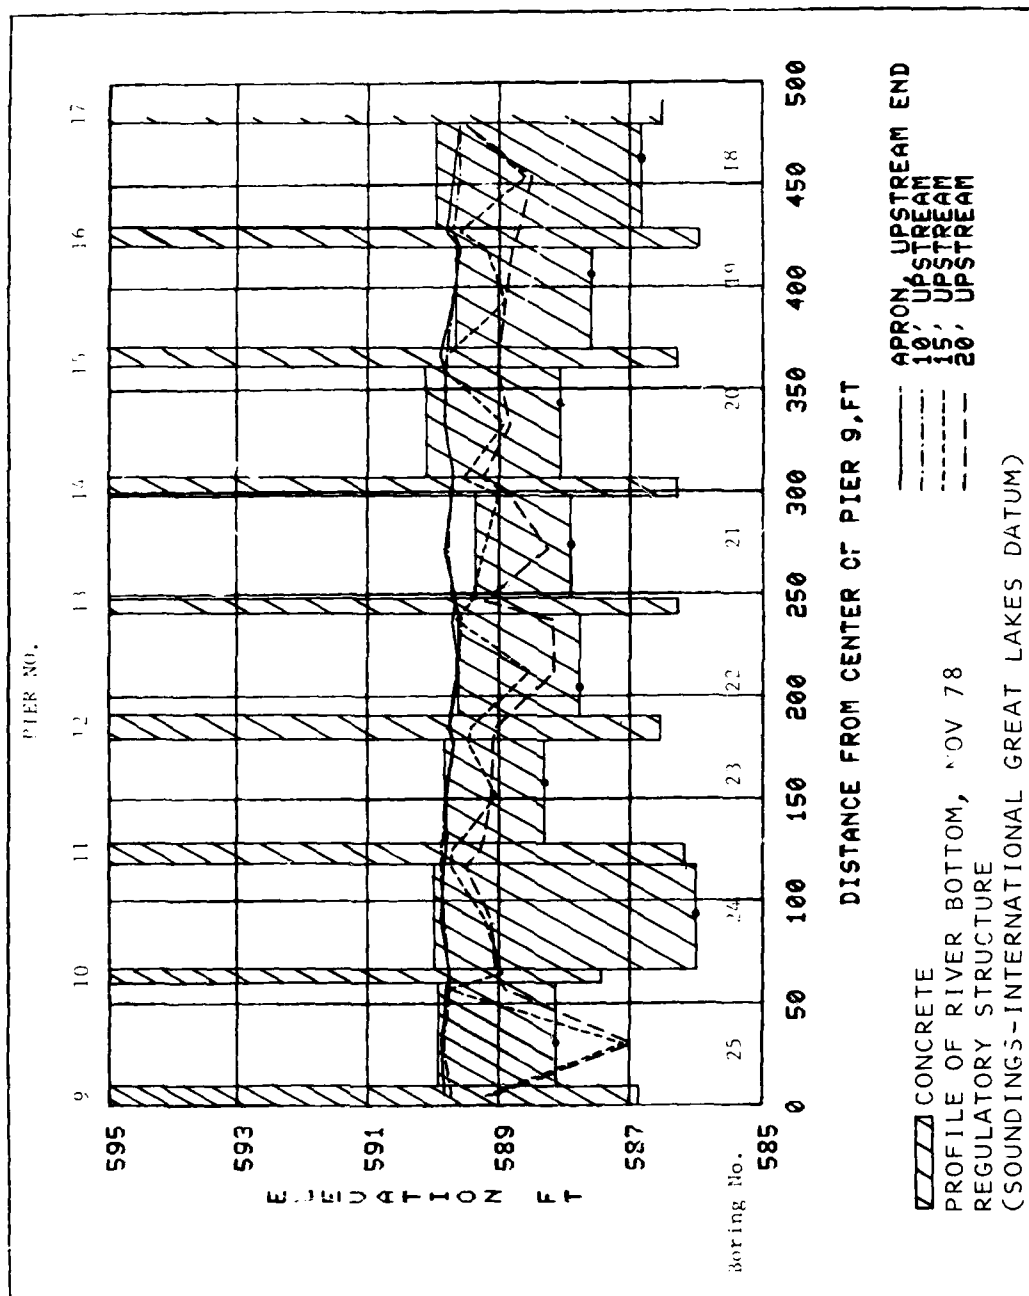
Figure 18. Upstream profile of soundings and concrete thickness data

61. Figure 17 contains three profiles; the solid line indicates top of apron and the dashed lines represent profiles taken at 0.5 and 7.0 ft downstream of the apron end. Figure 18 contains four profiles; the solid line at top of apron and the three dashed lines represent profiles taken 10, 15, and 20 ft upstream of the apron end.

114. Concrete deterioration. One contact, boring 18 (upstream apron), was described as weathered, open, and with loose sand grains. A second contact, boring 20, was described as tight but had weathered vesicles in the concrete adjacent to the bedrock. Figure 18 does not indicate the apron as being undercut near these two borings. Water passing along vertical or near vertical joints in the bedrock could have caused the weathered condition; if so, this is the first observed occurrence of such weathering. Cracking in the upstream apron is

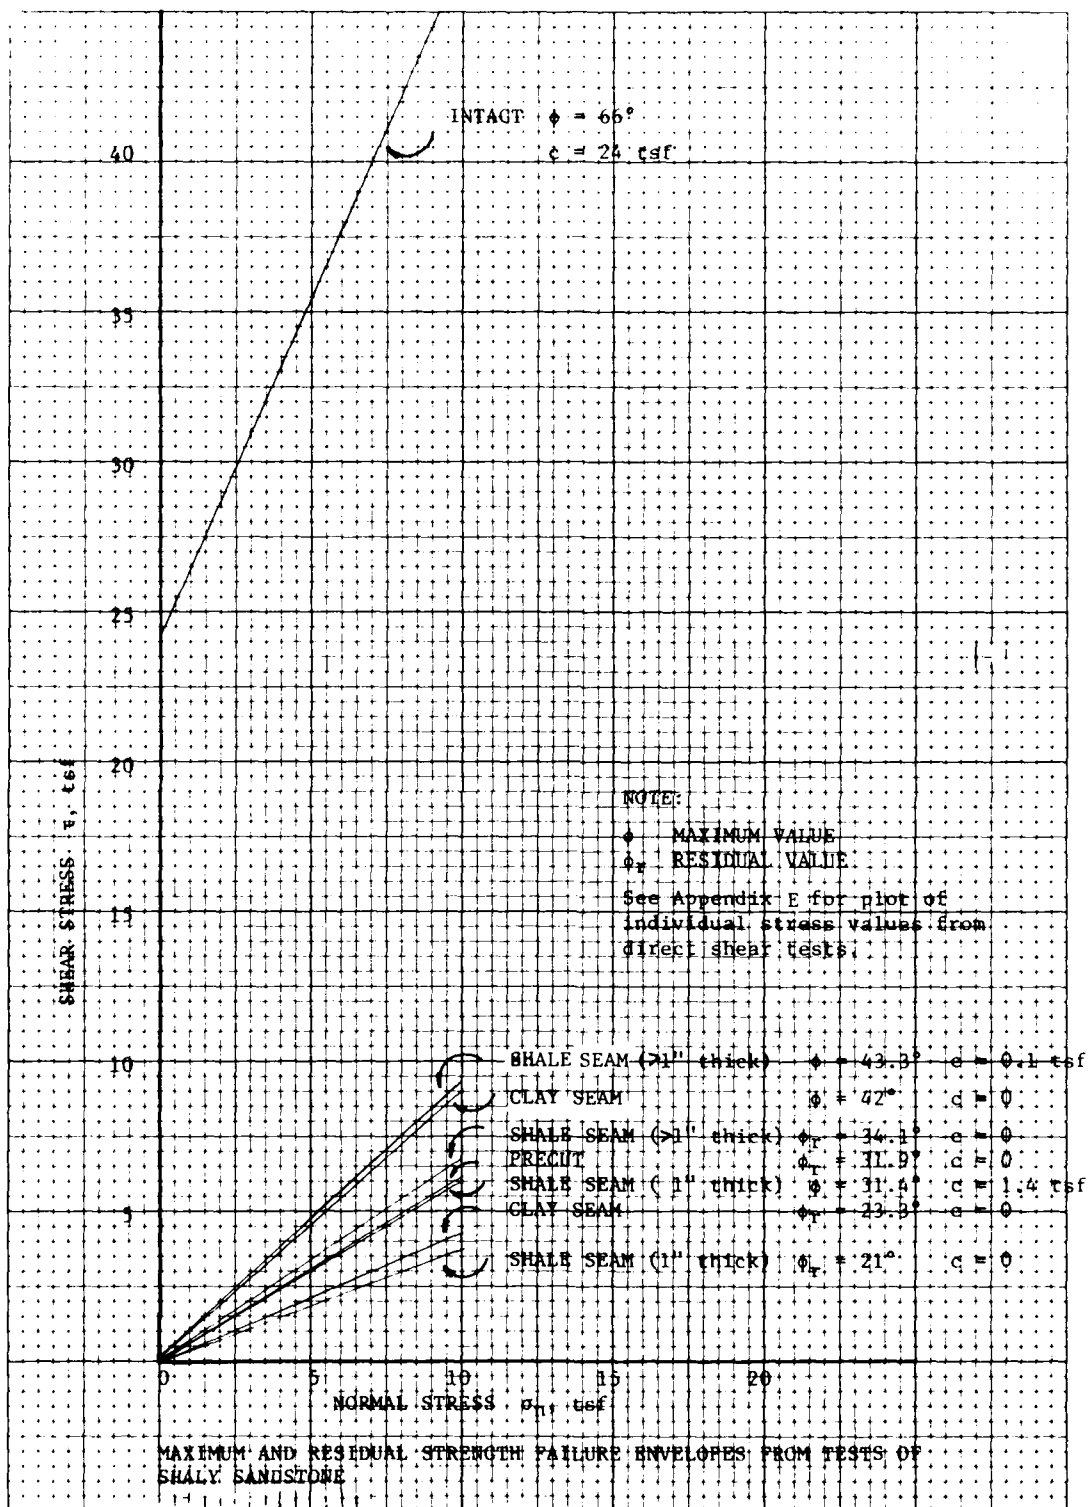
Figure 22. Summary plot of shaly sandstone failure envelopes

141. A summary plot of all the failure envelopes for the very hard, hard, and shaly sandstone is presented in Figures 20, 21, and 22. The bedrock feature having the lowest residual strength is the shale seam (1 in. thick) found in the shaly sandstone; the residual shear strength is  $\phi_r = 21^\circ$  and  $c = 0$ . The same shale seam has a maximum shear strength  $\phi = 31.4^\circ$  and  $c = 1.4$  tsf; see Figure 22. It will be noted in Figure 22 that the thicker shale seam (seams were removed from the host rock and tested as intact specimens) has higher shearing resistance than the thinner shale seams. An explanation may be that the thicker seam more fully developed its resistance to shearing by uniformly distributing the shear load throughout a homogenous material (all shale). In contrast, the thinner shale seam within the host rock developed an uneven stress distribution due to the two discontinuities adjacent to the seam. Uneven stress concentrations resulted, and the full shear strength of the shale was not reached.

142. A small number of core samples had slickensides along horizontal bedding, which is evidence of previous movement along the bedding planes. The residual shear strengths for the thin (1 in. thick) shale seams would be a conservative value to consider for sliding stability analysis.

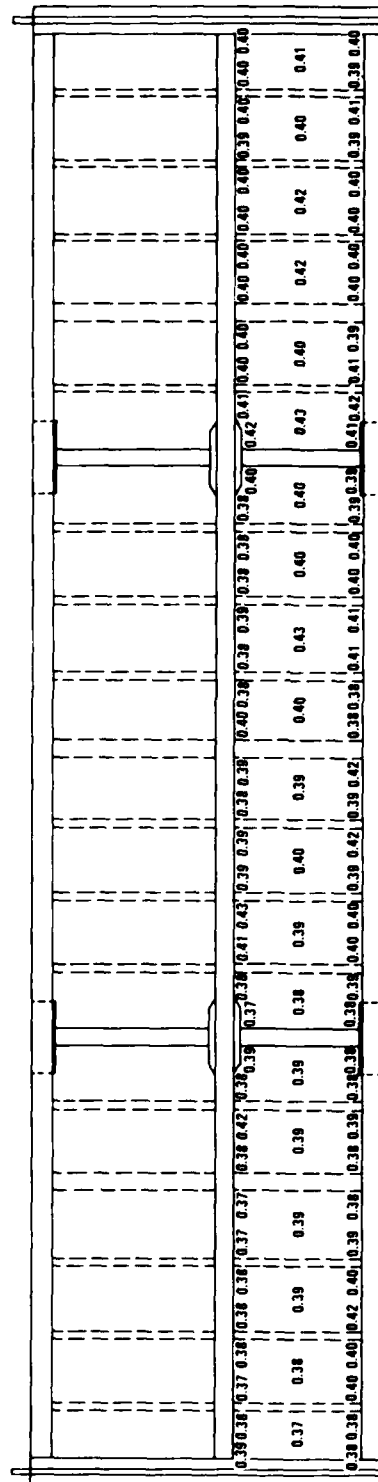
DETAILED TESTING  
LAKE SUPERIOR REGULATORY STRUCTURE  
UPSTREAM SIDE, GATE 9

The construction drawings specify that the gate skin plates contain sections of medium steel of 0.375-in. thickness. Evaluation of data given in Plates B1 through B8 shows that only 24 of the 870 areas scanned produced apparent thicknesses less than 0.375 in. The mean thickness measurements for the eight gate skin plates ranged between 0.39 in. and 0.41 in. The grand mean for the eight gates is 0.40 in. The apparent presence of 0.025 in. of steel thickness is not considered to be unusual since it is not uncommon for steel plate to be over-toleranced in order to assure compliance with specifications. It is difficult to ascertain what were standard practices on tolerance setting in the early 1900's when this steel was manufactured. The data obtained from the ultrasonic inspections do not indicate that there has been any appreciable loss in gate skin thickness.

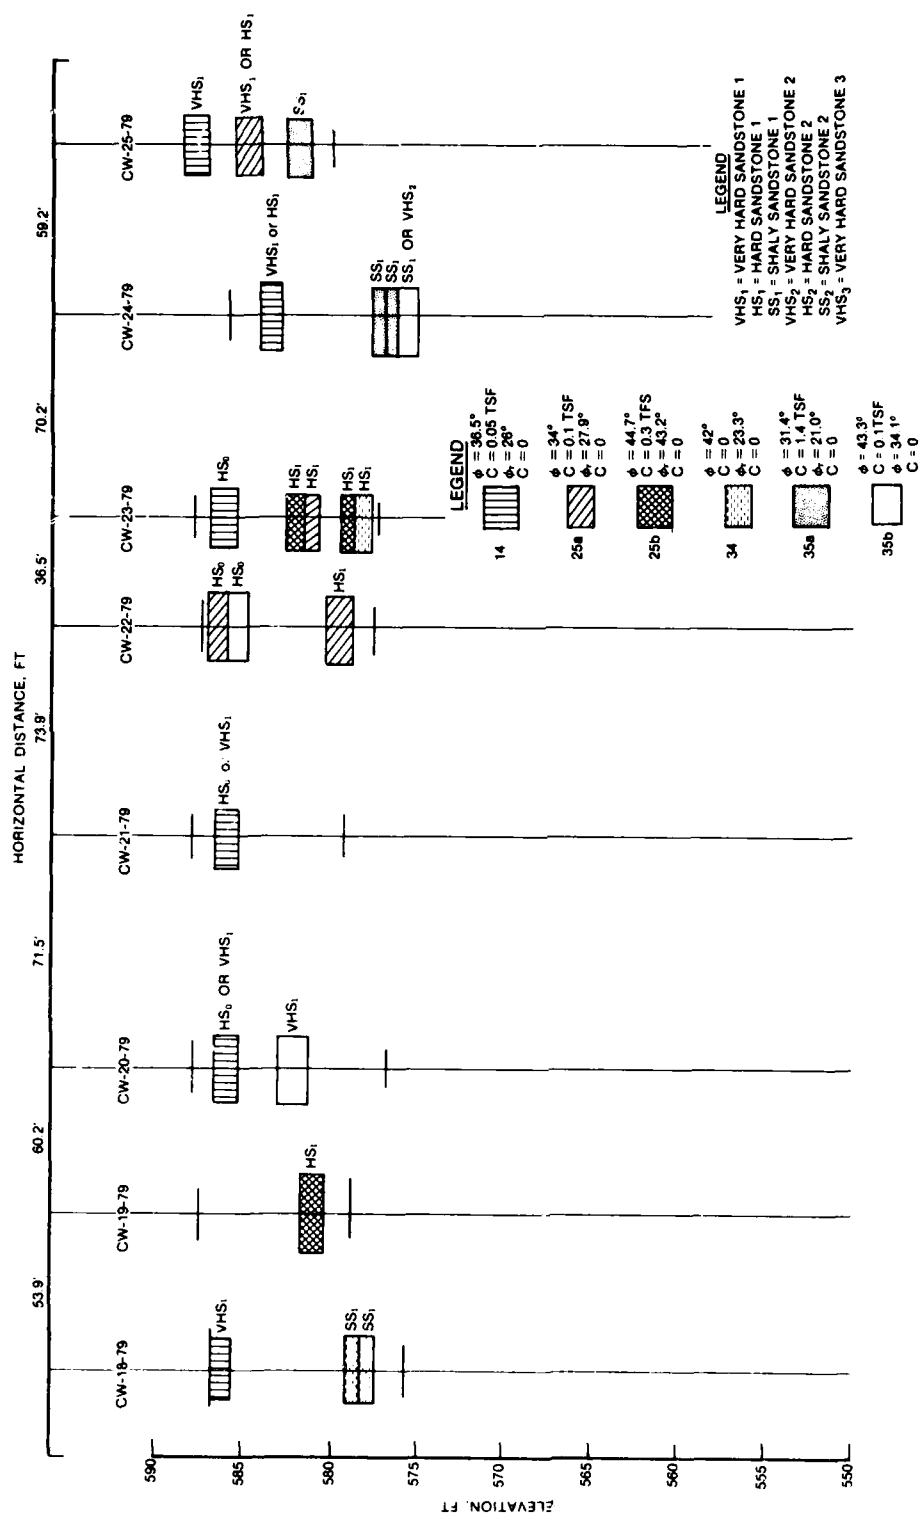
Figure F2. Location of clay and shale seams in upstream section (Section A-A', Plate D1) of core holes

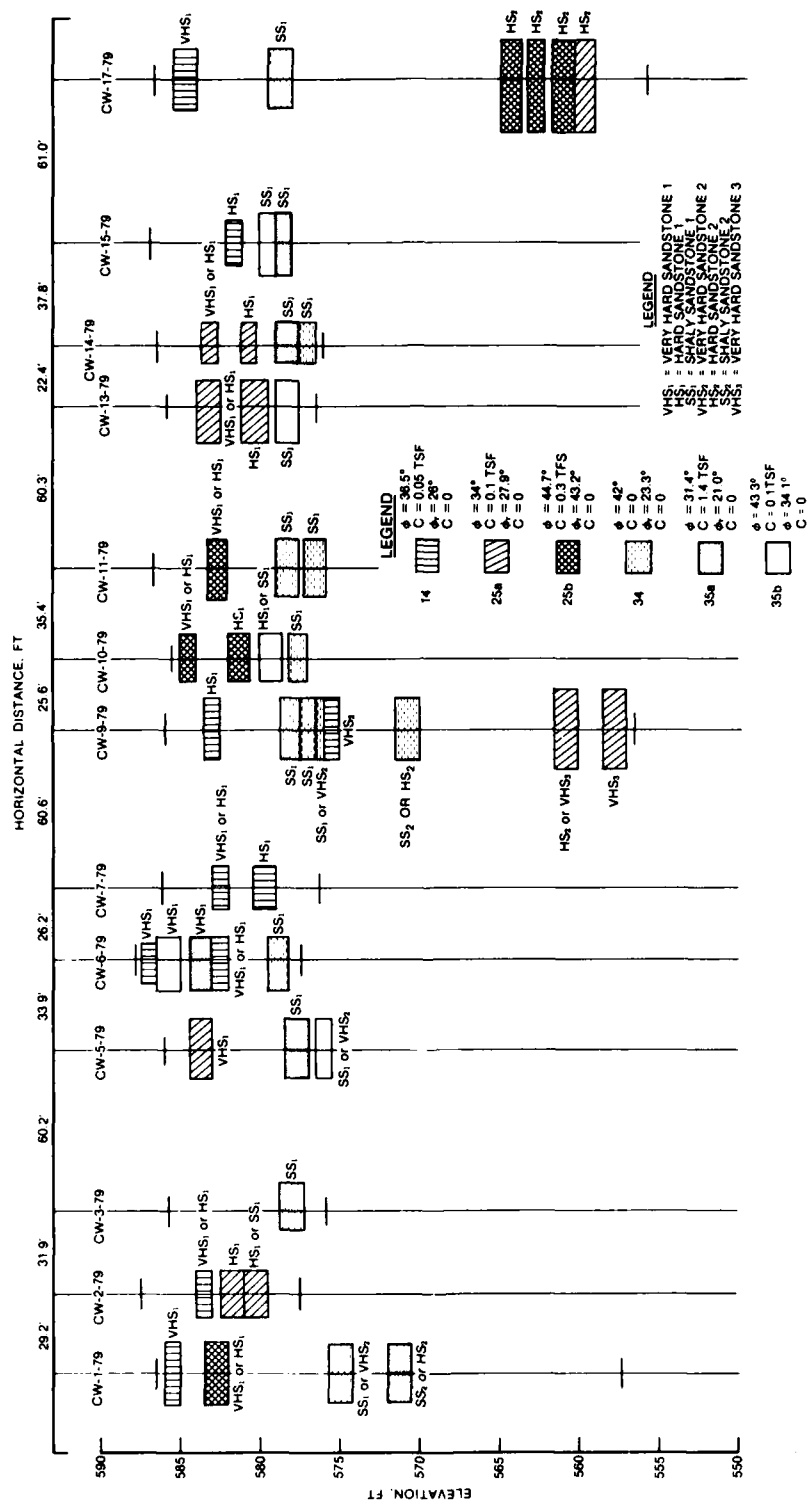
Figure F3. Location of clay and shale seams in downstream section (Section D-D', Plate D1) of core holes

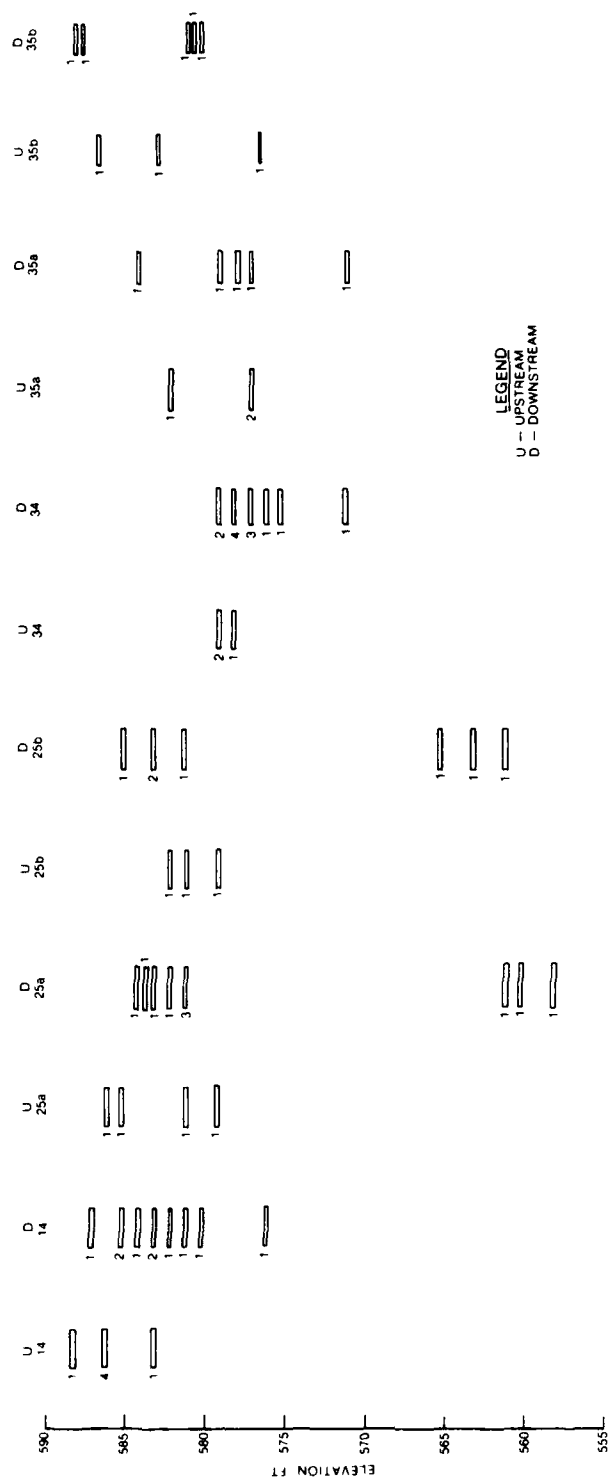
Figure F4. Composite location of clay and shale seams in core holes of Section A-A' and Section D-D' (Plate D1)
